SEOHAN ANTAMINE CO. LTD TEST REPORT

ICC-ES AC92 SECTION 4.7.1.1 TESTING ON HPL, WALL CLADDING

L3571.04-109-44

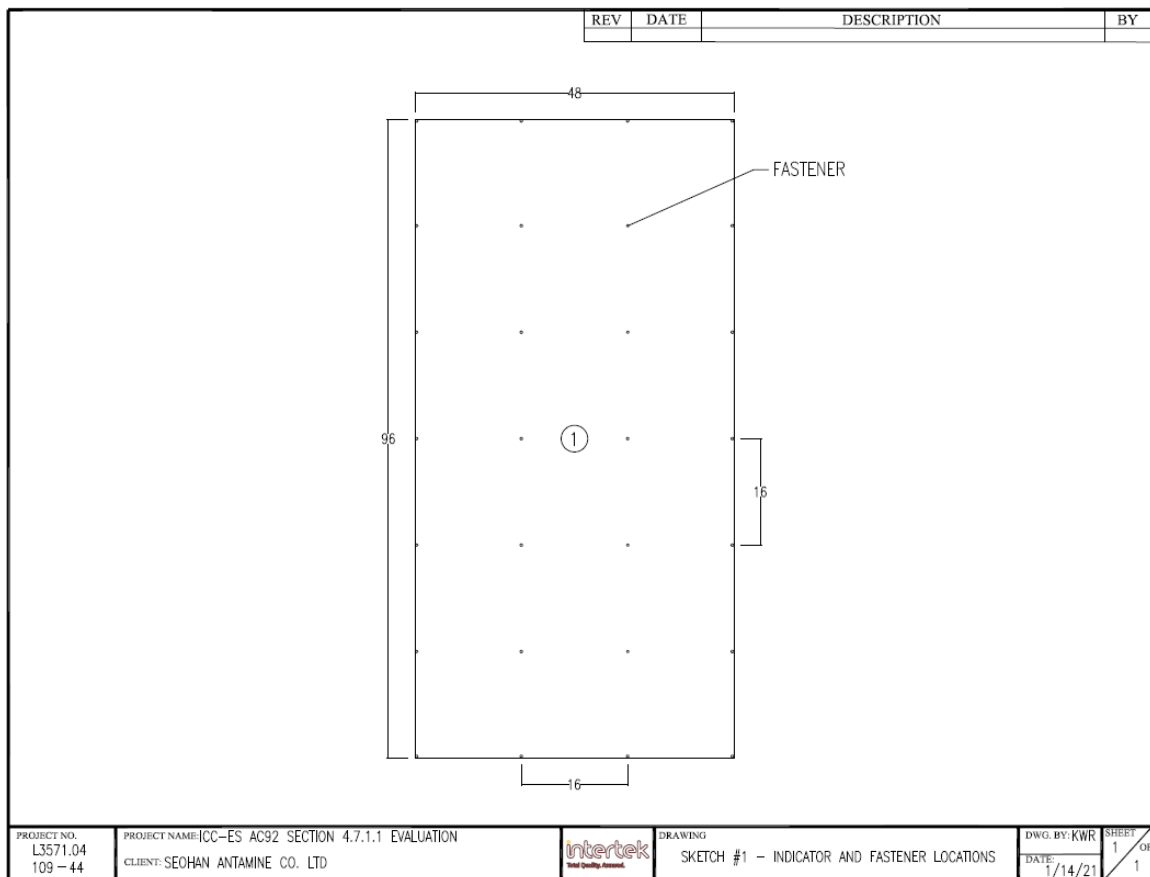
Sketch #1
Deflection Locations

The temperature during testing was 14 - 20°C (57 - 70°F). All loads were held for 10 seconds. All deflections and permanent sets were taken across the midspan of the panel. Reference Sketch #1 for deflection locations. The results are tabulated as follows:

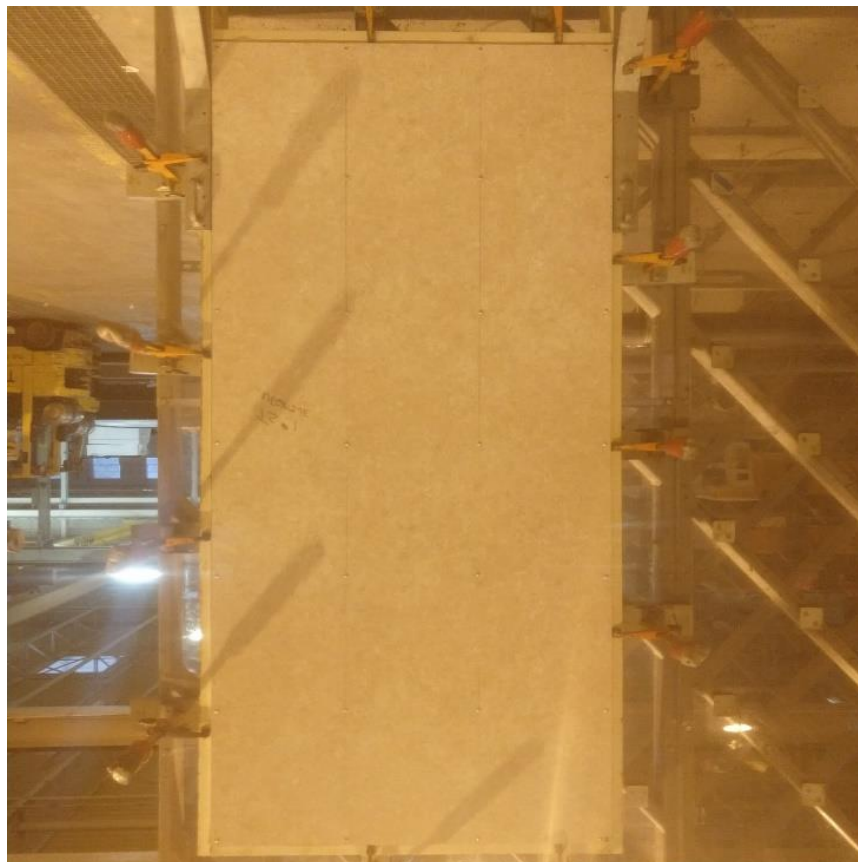
Photo No. 1
View of Test Specimen #1

Test Specimen #1: Negative Loads

Note 3: Test specimen failed prior to target pressure. Screw heads broke off and a crack developed in the panel.

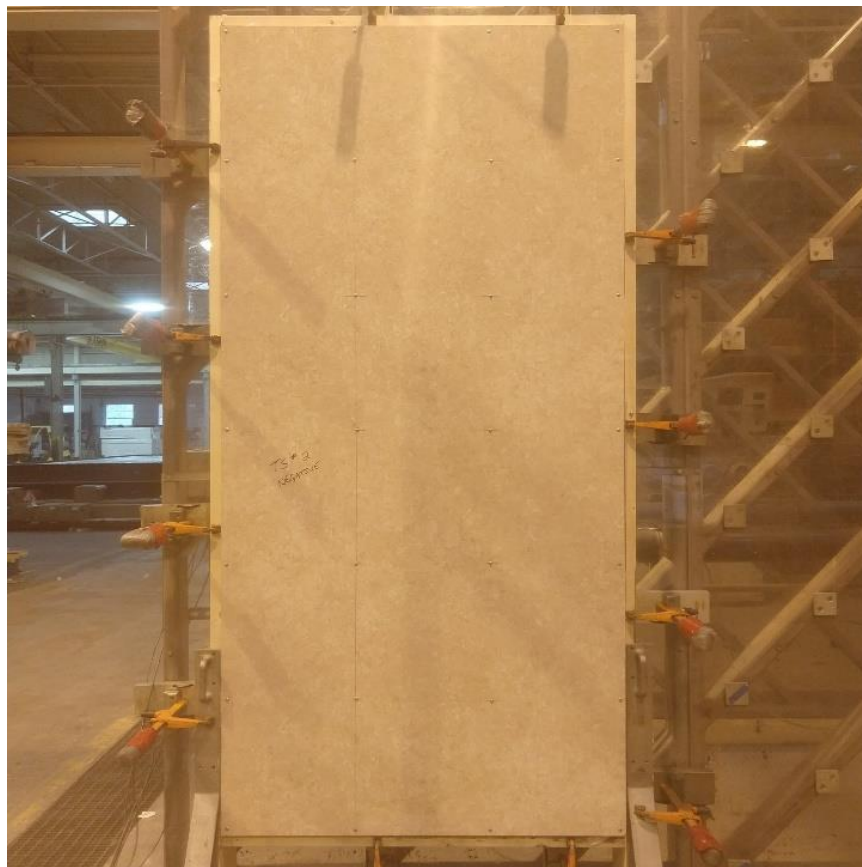
Photo No. 2
View of Test Specimen #2

Test Specimen #2: Negative Loads

Note 4: Test specimen failed 1 second into target load. Panel broke at the fastener locations.

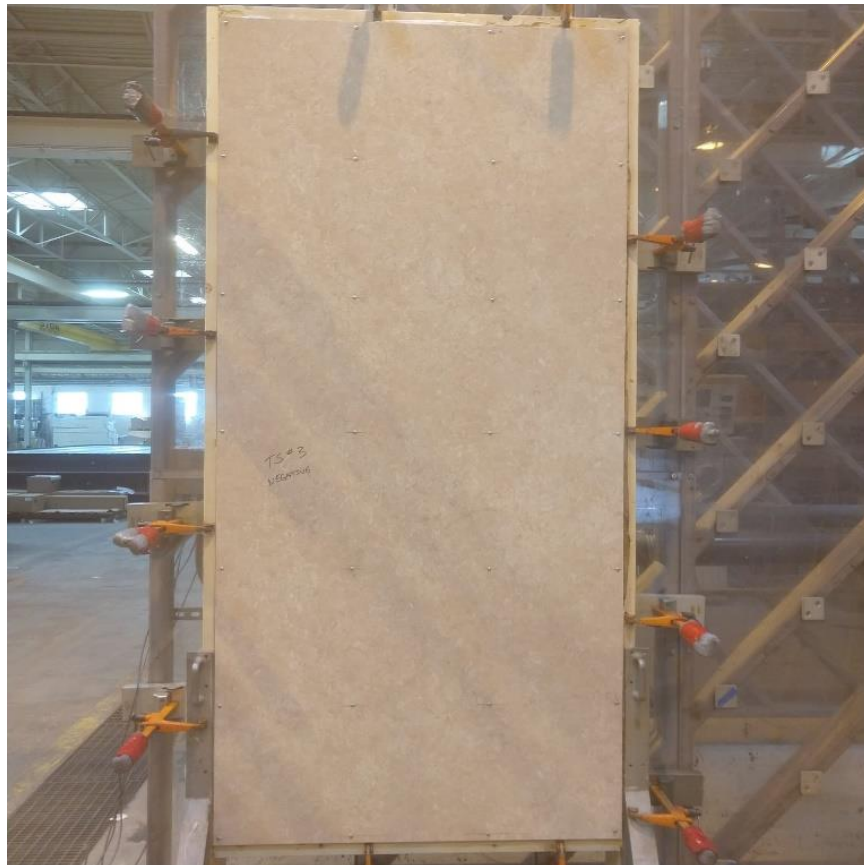
Photo No. 3
View of Test Specimen #3

Test Specimen #3: Negative Loads

Note 5: Test specimen failed 6 seconds into target load. Top of panel broke off.

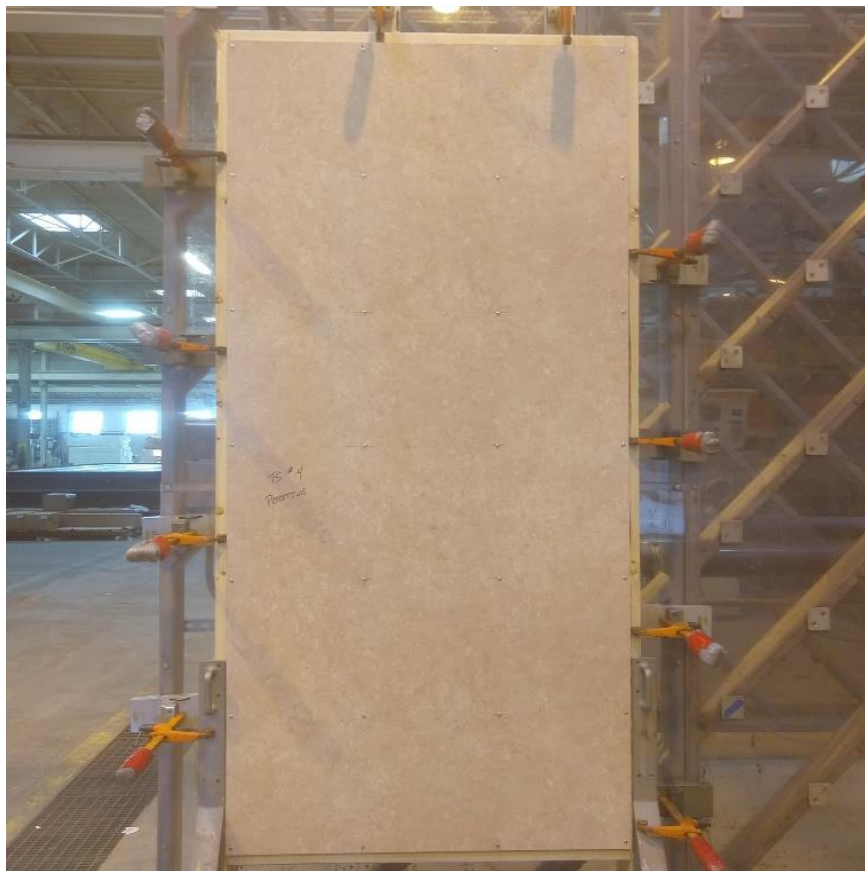
Photo No. 4
View of Test Specimen #4

Test Specimen #4: Positive Loads

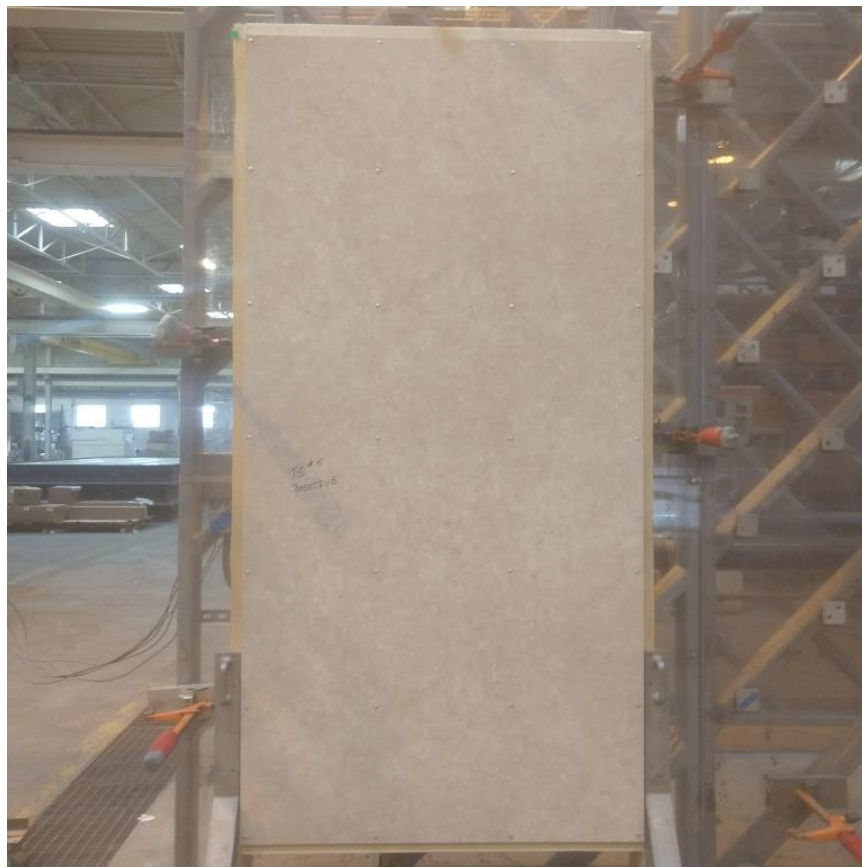
Photo No. 5
View of Test Specimen #5

Test Specimen #5: Positive Loads

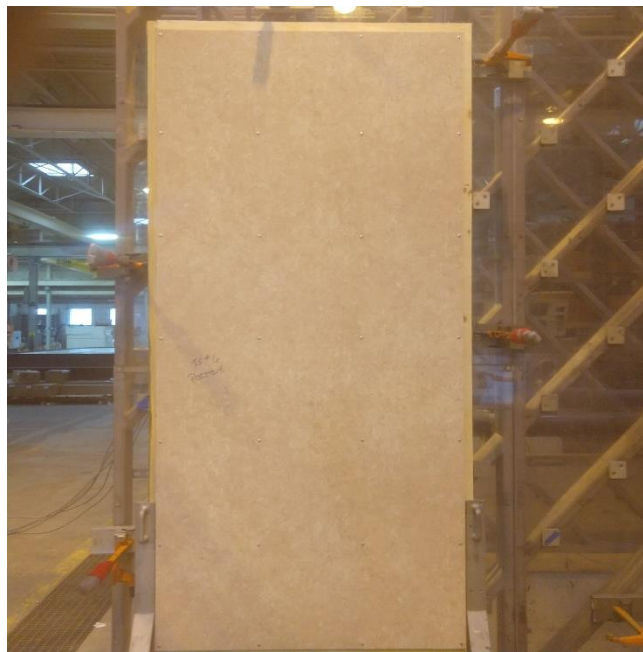
Photo No. 6
View of Test Specimen #6

Test Specimen #6: Positive Loads
